The Overlook II HOA
Scottsdale, AZ

Report #: 25455-3
Beginning: January 1, 2025
Expires: December 31, 2025

RESERVE STUDY
Update "With-Site-Visit"

April 11, 2024

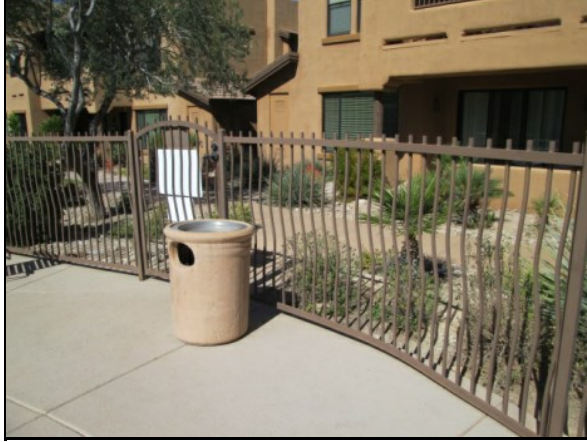
Comments: Fence is securely mounted. Some rust noted along the base. Future replacement should be anticipated.

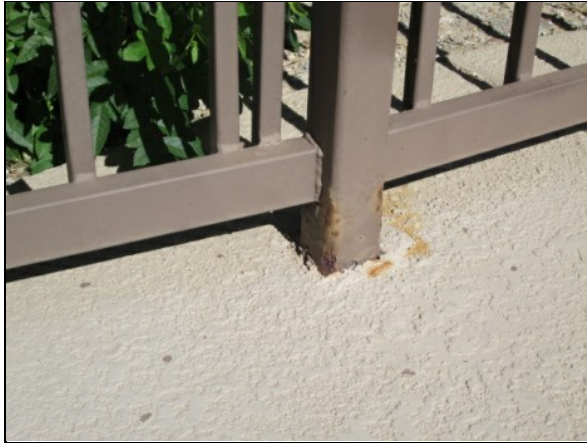
Comments: Surfaces are faded, weathered, and rust is starting to rust. Repaint periodically to maintain the appearance and to inhibit rust.

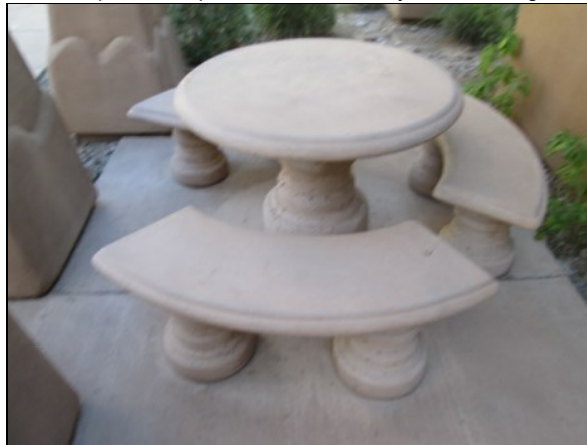
Comments: Concrete furniture includes (3) picnic tables and (4) trash receptacles. Long life expectancy under normal circumstances. It would still be prudent to plan for replacement eventually. No cracking or damage noted.
