**RESERVE STUDY**

**HACIENDA ROYALE HOMEOWNERS ASSOCIATION**

FDReserve Studies, LLC  
Goodyear, AZ 85338

1/5/2017

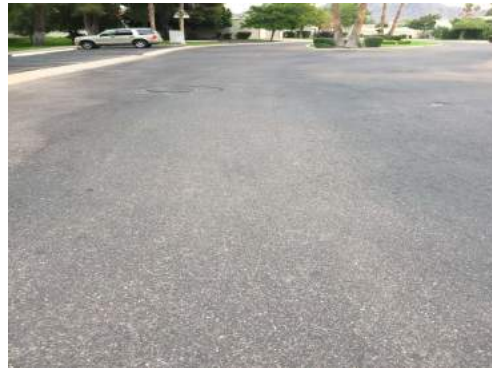
**Asphalt - Overlay - 2046**

Good condition.

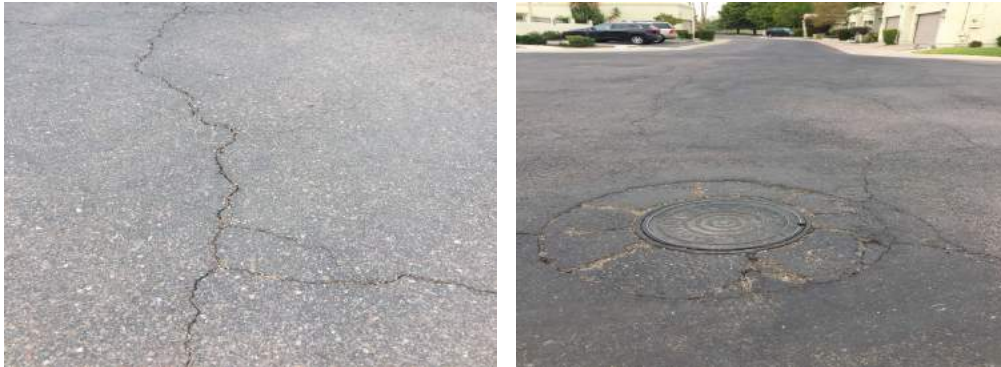
*Asphalt - Repair & Surface Treatment continued...*

Fair condition. Needs crack seal and repair. Recommend a longer lasting seal coat such as HA5 to be applied next year with a 5 year life and warranty on HA5, slightly more expensive to apply but it has been noted that this proprietary product is lasting longer than 5 years.

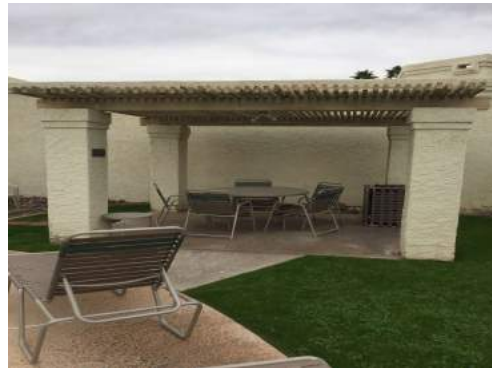
**Pool Equipment Roof & Pergola Roof - Replace - 2017**

One time cost to tear our and replace roof with aluma wood. Invoice from The Rutan Group Premium Outdoor Living for a total of \$3350.

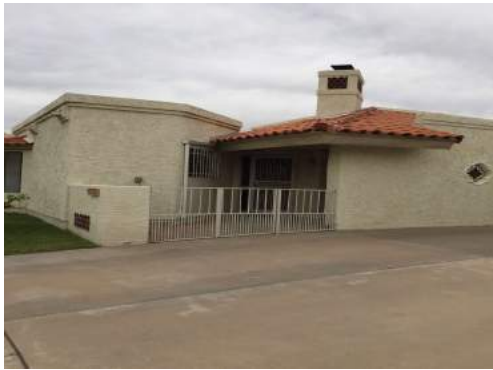
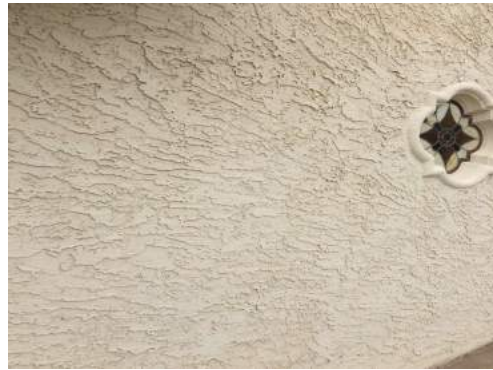
**Buildings - Paint - 2018**

Needs paint. This asset, and the information contained herein, has been provided by the association.

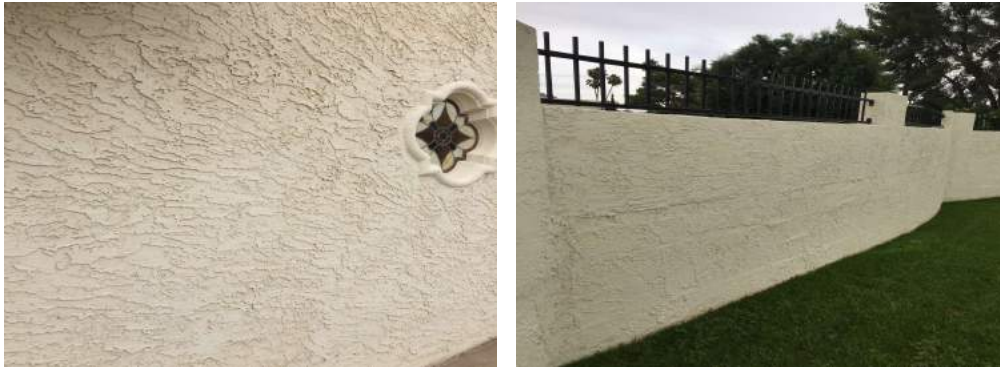
*Masonry Stucco Walls - Paint continued...*

Poor condition. Needs paint.

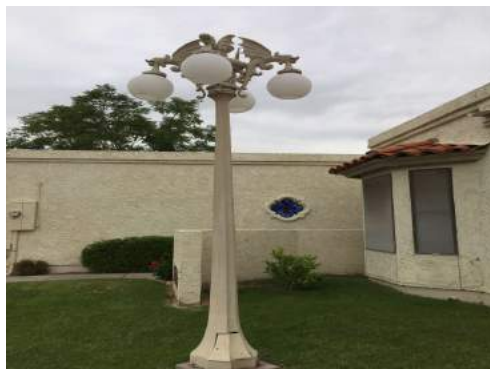
**Pole Lights - Paint - 2018**

Fair condition. Needs paint.

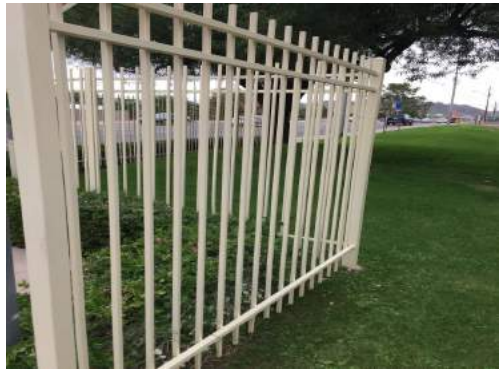
**Wrought Iron Fencing - Paint - 2018**

Good condition. Rusting at bottom from irrigation spray. The useful life of this asset has been extended due to its present condition.

52' X 6' high wrought iron fence located at entry

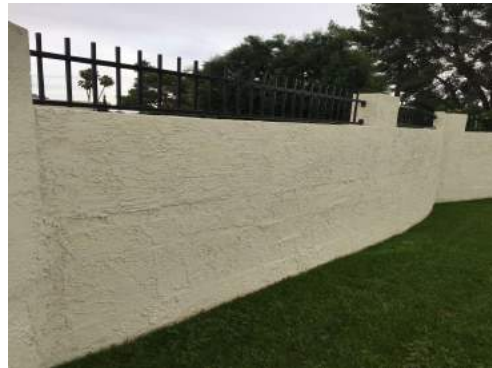
**Masonry Stucco Walls - Repair - 2017**

Good condition. Block stucco coated wall w/ 24" wrought iron on top, located inside community cul-de-sac. Block stucco coated wall around just pool equipment 34 lf X 5' high, 75 X 5' located around pool area and 5.5' X 160 cul-de-sac through to pool area. It is estimated that a percentage of the stucco walls will require repair or replacement. The actual condition of the stucco walls should be monitored through time and the estimates adjusted accordingly. This component is budgeted for 5% of the wall for repair or replacement every 5 years.

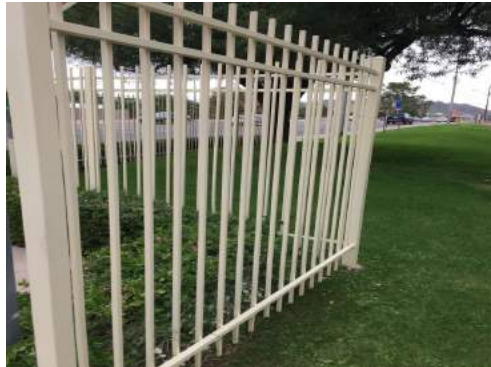
*Wrought Iron Fencing - Replace continued...*

Good condition. Rustining noted on bottom due to irrigation spray.

52' X 6' high wrought iron fence located at entry

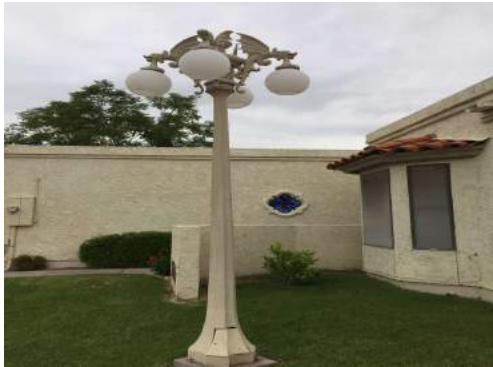
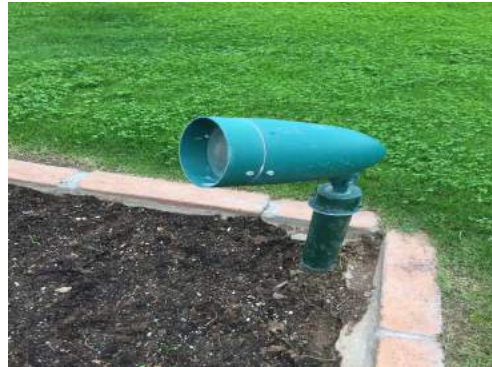
**Pole Lights & Spot Lights - Replace - 2030**

Good condition. Should last a long time as maintenance repairs and replaces parts when needed. 2 large spots for fountain. Less than \$500 so not funded. These lights should be monitored frequently as they cannot be replaced with similar product.

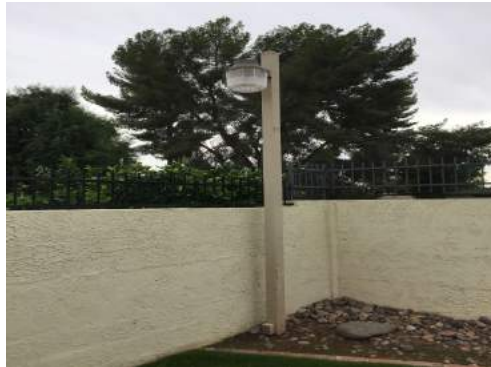
*Pool Lights - Replace continued...*

Fair condition. Rusting at bases. Two 10' high metal pole lights. The useful life of this asset has been extended due to its present condition.

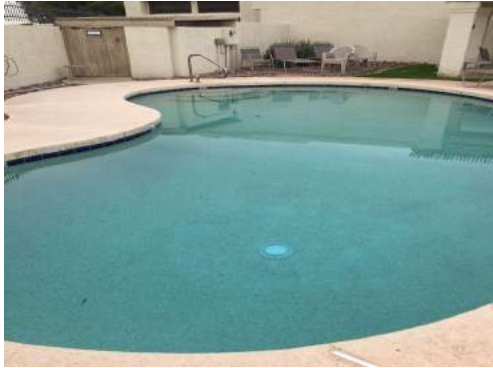
**Pool - Resurface - 2024**

Good condition. 750 sf of pebbletec and 87' of 4" trim tile. The actual date this item was "placed in service" was not available. For budgeting purposes, we have estimated this date based upon its present condition. The useful life of this asset has been extended due to its present condition.

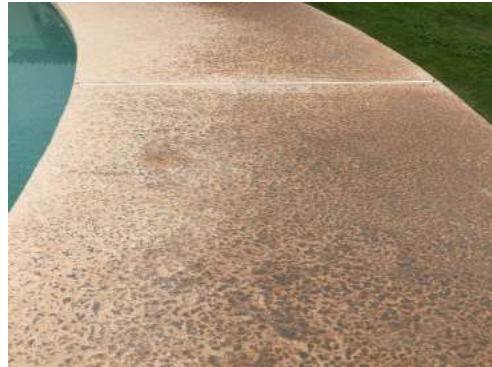
*Pool Deck - Recoat continued...*

Poor condition. Needs recoat. approximately 450 sf.

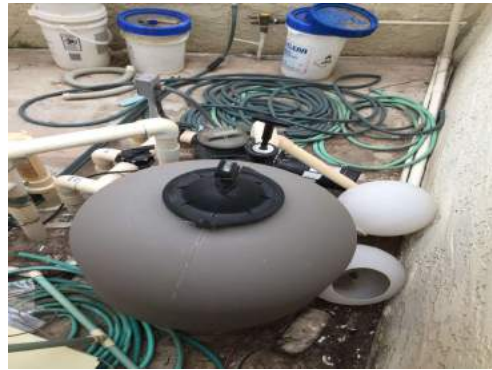
**Pool Filter - Replace - 2020**

No access, appear to be in good condition. The actual date this item was "placed in service" was not available. For budgeting purposes, we have estimated this date based upon its present condition. We placed a phone call requesting this information from the current landscape maintenance contractor during the preparation of this report, to which we received no response. If this information should become available at a later date, we will be happy to incorporate it into our report.

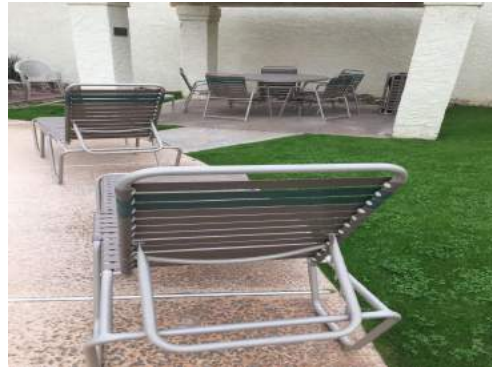
*Pool Furniture - Replace continued...*

Good condition. These can be restrapped and powdercoated to save money. The actual date this item was "placed in service" was not available. For budgeting purposes, we have estimated this date based upon its present condition.

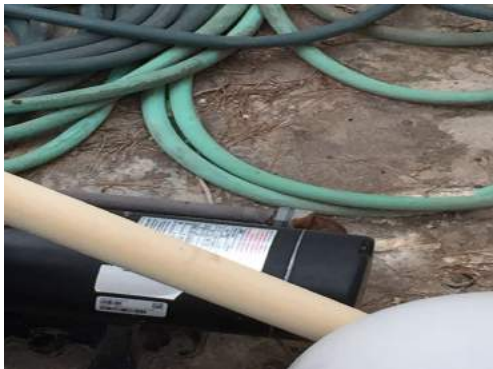
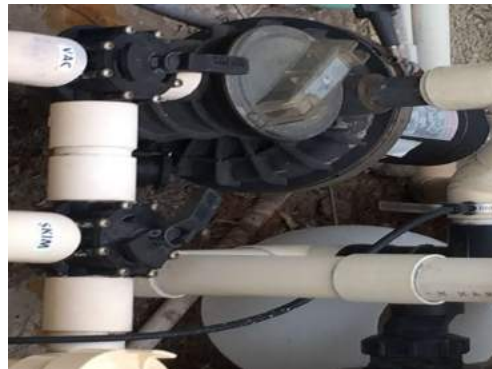
No access, appear to be in good condition. The actual date this item was "placed in service" was not available. For budgeting purposes, we have estimated this date based upon its present

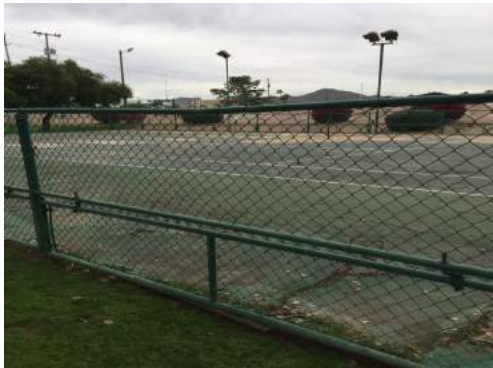
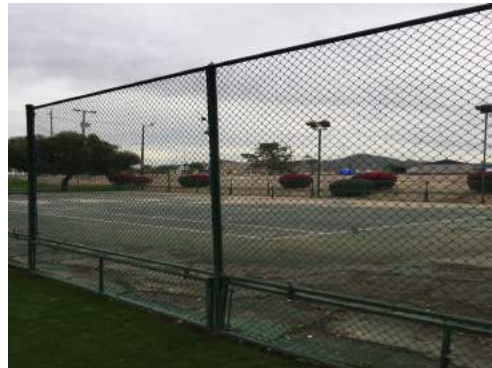
**Tennis Court - Replace**

Poor condition. It is the intention of the client not to maintain or replace this asset and therefore we have excluded budgeting for it in our report. It is listed for inventory purposes only. Suggest dog run area or 2 pickleball courts or tear out for park area.

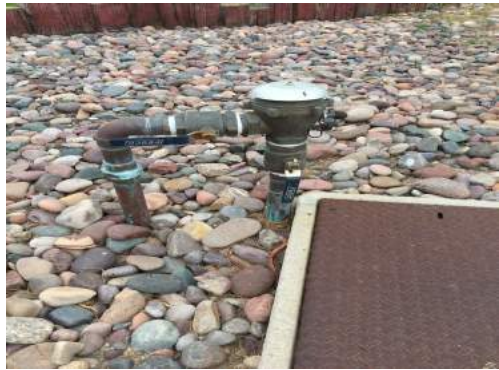
**Backflow Preventer - Replace - 2022**

Asset ID	1016	1 EA	@ \$600.00
		Asset Cost	\$600.00
		Percent Replacement	100%
	Equipment	Future Cost	\$695.56
Placed in Service	March 1980	Assigned Reserves	<i>none</i>
Useful Life	25		
Adjustment	17	Annual Assessment	\$68.13
Replacement Year	2022	Interest Contribution	<u>\$0.48</u>
Remaining Life	5	Reserve Allocation	\$68.61

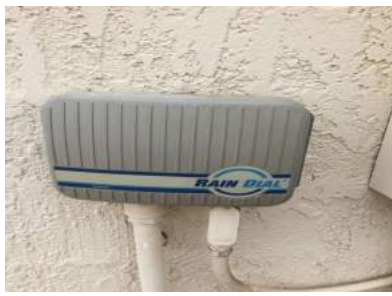
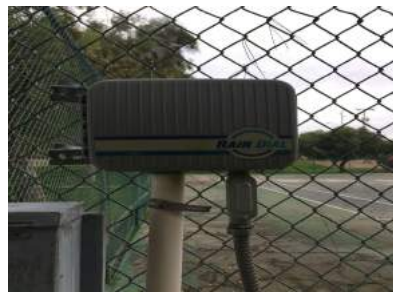
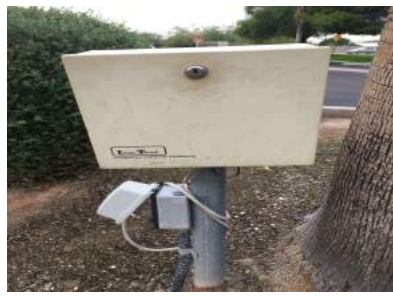
**Irrigation Controllers - Replace - 2028**

Good condition. The actual date this item was "placed in service" was not available. For

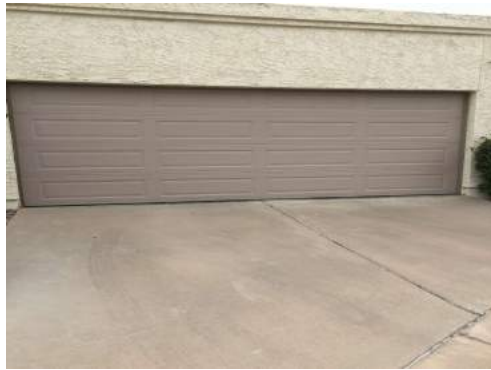
**Garage Doors - Replace - 2039**

Good condition. Aluminum 16' X 7' single panel.

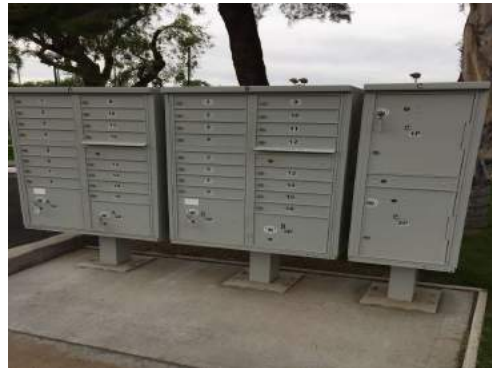
**Mailboxes - Replace - 2026**

Good condition. The useful life of this asset has been extended due to its present condition.

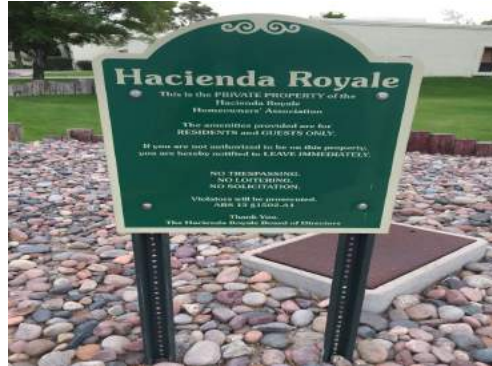
Good condition. Metal sign should last lifetime of community.

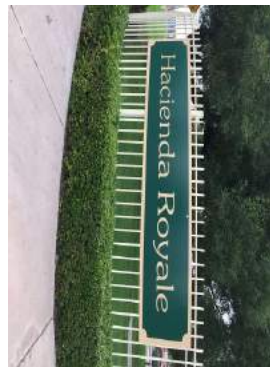
**Monument Sign - Replace**

Good condition. Metal sign should last lifetime of community.
