The Overlook II HOA
Scottsdale, AZ

Report #: 25455-3
Beginning: January 1, 2025
Expires: December 31, 2025

RESERVE STUDY
Update "With-Site-Visit"

April 11, 2024

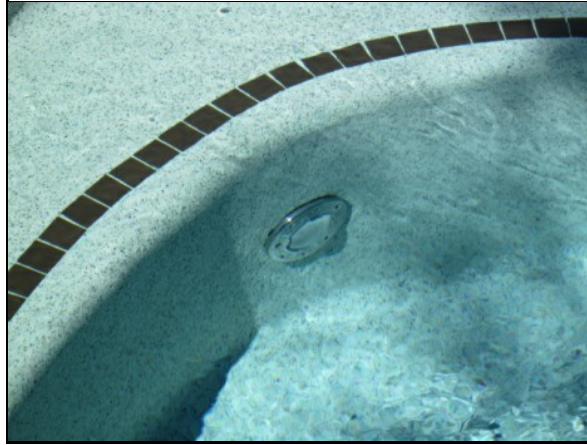
Comp #: 1207 Spa Light - Replace

Funded?: No. Cost for this single light is too small for Reserve designation. Replace when needed as an Operating expense, or include with the pool lights.

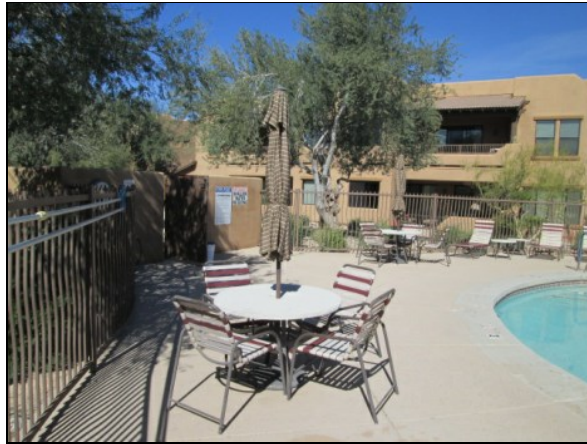
Comp #: 1210 Pool Furniture - Replace

Comments: Pieces include (20) lounges, (24) chairs, (5) dining tables, (8) tea tables, and (5) umbrellas. Pieces are being replaced or refurbished periodically, so the condition varies. This component funds for complete replacement. The combined cost with the refurbish component accounts for total cost estimate.

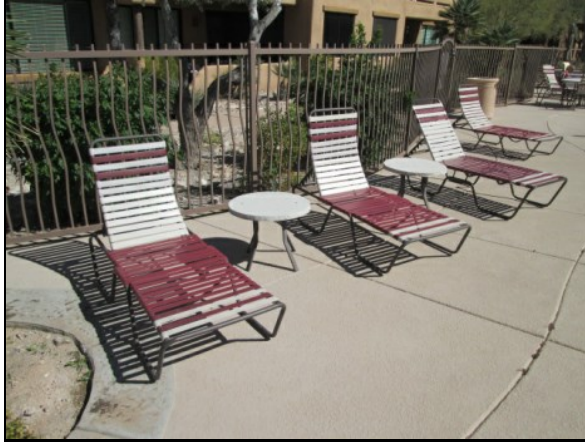
History: Spent ~\$3,300 during 2019-2023 for refurbishment and partial replacements.

Comments: This component provides an allowance to periodically replace straps, repair frames, and replace individual pieces as needed. Several straps and frames are weathered.

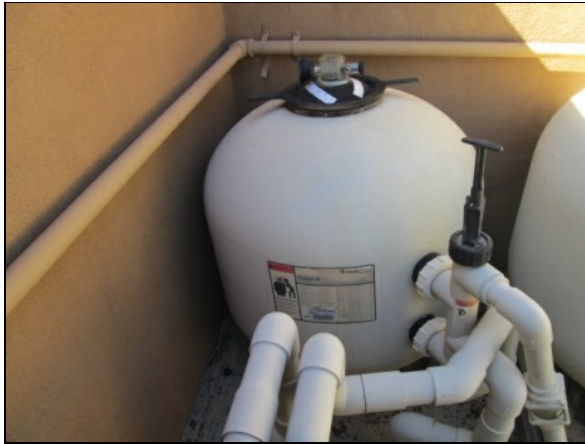
Comp #: 1220 Pool/Spa Filters - Replace (A)

Comments: Appears functional and in fair shape. Future replacement should be anticipated.

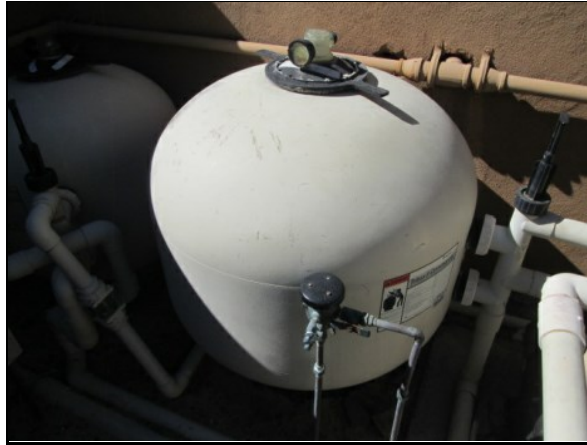
Comp #: 1220 Pool/Spa Filters - Replace (B)

Comments: Appear functional with no issues reported. Exterior shells do exhibit heavy fading and weathering. Based on age, replacement should be anticipated in the near future.

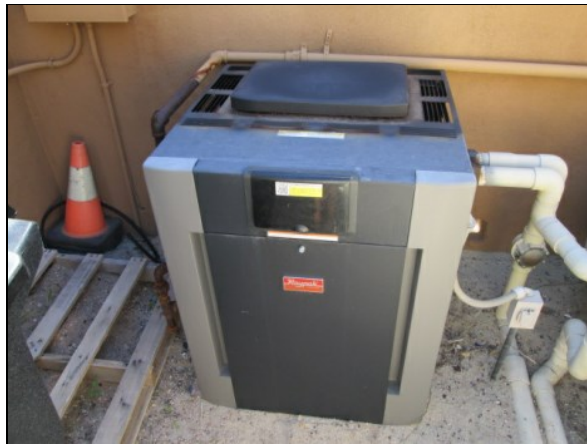
Comp #: 1223 Pool/Spa Heaters - Replace (A)

History: Replaced in 2020 for ~\$3,000. Previously installed in 2010.

Comments: This heater services the spa. It appears to be in good working condition.

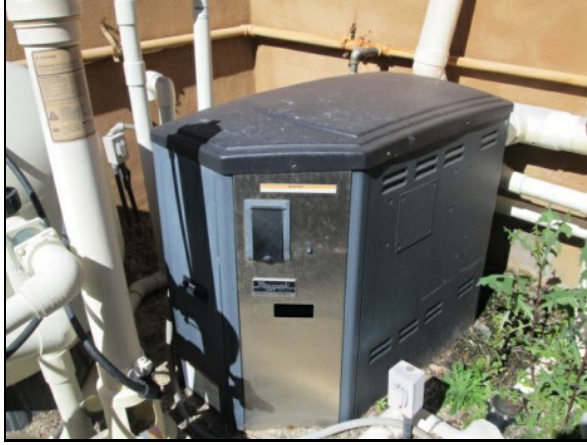
Comp #: 1223 Pool/Spa Heaters - Replace (B)

Comments: Appears functional. This is a high efficiency heater with a stainless steel heat exchanger.

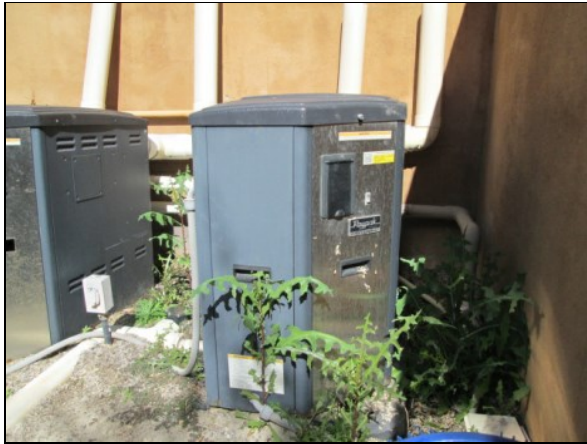
Comp #: 1223 Pool/Spa Heaters - Replace (C)

Comments: Appears functional. This is a high efficiency heater with a stainless steel heat exchanger.

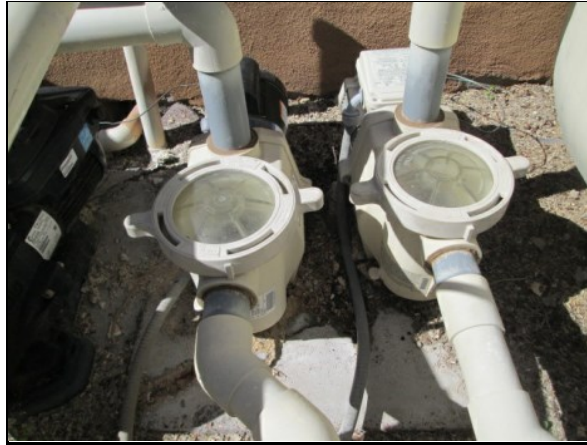
Comp #: 1224 Pool/Spa Pumps - Replace (A)

History: Replaced during 2019 for ~\$3,000.

Comments: These pumps service the pool. Periodic repair and motor replacement should be addressed as a maintenance issue. This component funds for replacement of the pump and motor assembly.

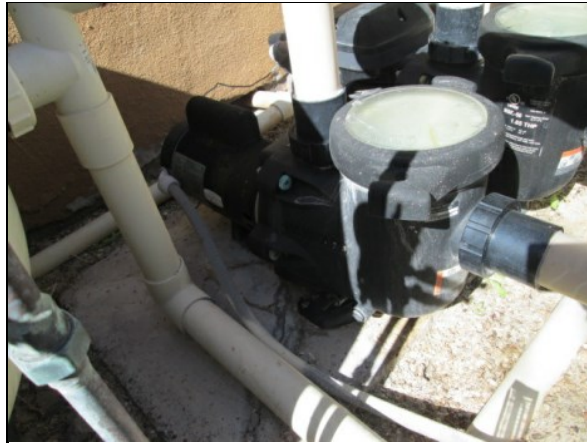
Comp #: 1224 Pool/Spa Pumps - Replace (B)

History: Likely replaced around 2015.

Comments: Age is based on serial number. This pump services the spa. Periodic repair and motor replacement should be addressed as a maintenance issue. This component funds for replacement of the pump and motor assembly.

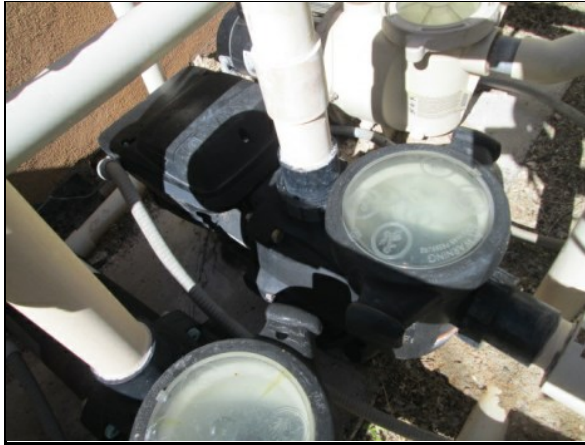
Comp #: 1224 Pool/Spa Pumps - Replace (C)

History: Likely replaced around 2022.

Comments: Age is based on serial number. These pumps service the spa. Periodic repair and motor replacement should be addressed as a maintenance issue. This component funds for replacement of the pump and motor assembly.

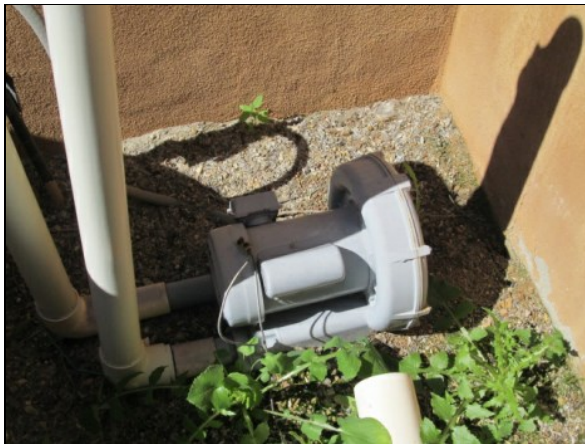
Comp #: 1228 Spa Blower - Replace

Funded?: No. Replacement cost is expected to be under the Reserve expense threshold. Replace as needed as an Operating expense.

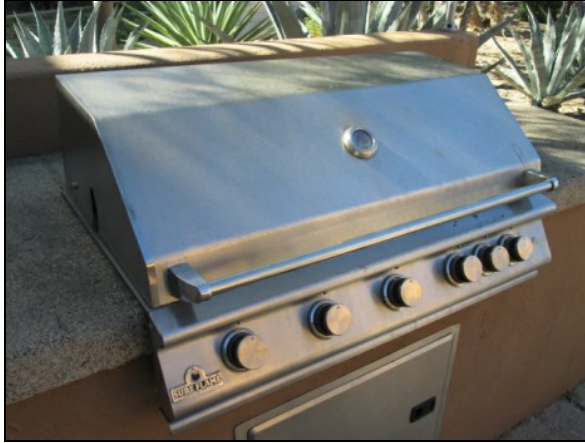
Comp #: 407 BBQ Grill - Replace

Comments: This is an elite 5-burner gas grill. Appears older but functional. Weathering and wear evident on the counter and grill. Additional funding is provided to repair or refurbish the counter when the grill is replaced.

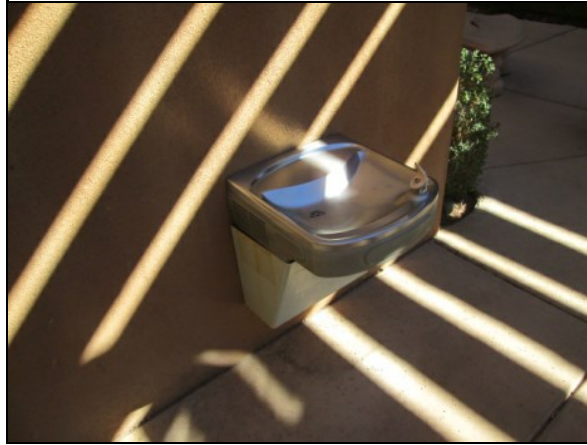
Comp #: 420 Drinking Fountain - Replace

Funded?: No. Cost is below the Reserve expense threshold. Treat replacement as an Operating expense when needed.

Comments: Drinking fountain is old and weathered. It is starting to rust. Replacement should be anticipated in the near future.

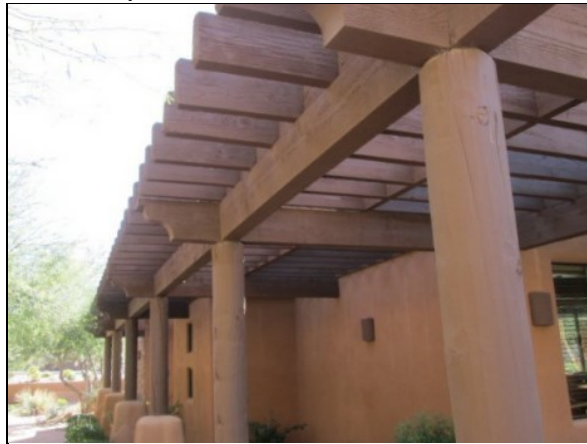
Comp #: 510 Wood Pergola - Replace

History: Repaired in 2023 for \$2,050. Previously installed in 2005.

Comments: The pergola is still intact with no major issues. Warped wood, splintering, and cracking noted throughout.

Replacement should be anticipated eventually.

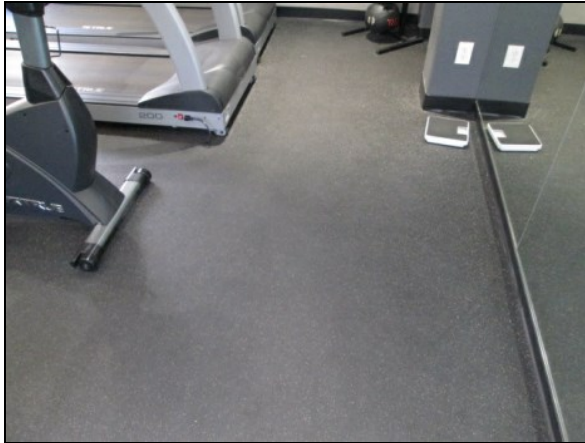
Comp #: 901 Rubber Floor - Replace

Comments: Good conditions noted. Funding is provided for future replacement.

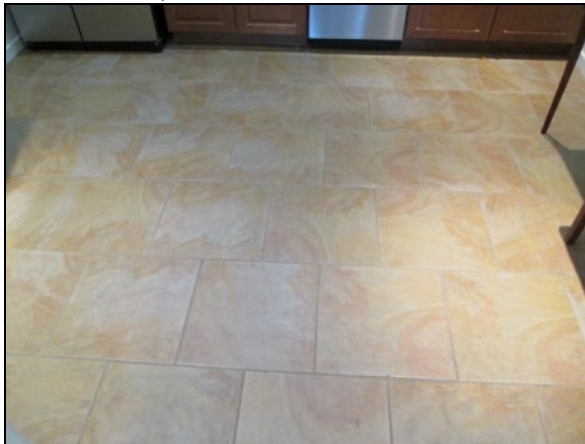
Comp #: 903 Tile Floor - Replace

Comments: Still decorative and in good shape. There are no cracked tiles or cracks along grout lines. Long life component, however future replacement should still be anticipated.

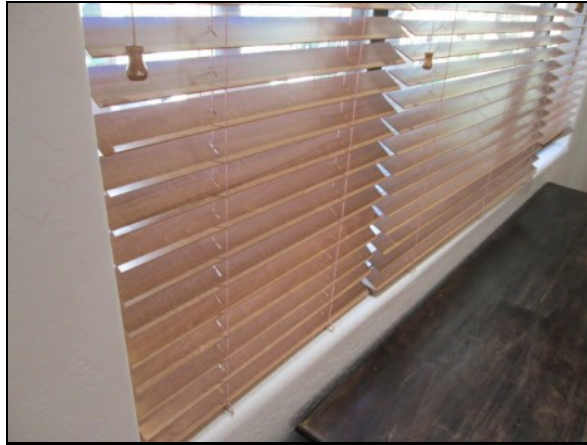
Comp #: 908 Window Blinds - Replace

Comments: Appear functional and not abused. Complete replacement should be expected eventually to maintain uniformity.

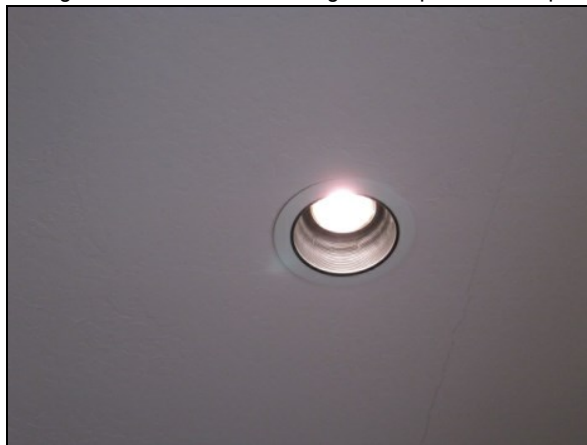
Comp #: 910 Interior Lights - Replace

Comments: These are recessed can lights. Still functional and in good shape. Future replacement should still be expected.

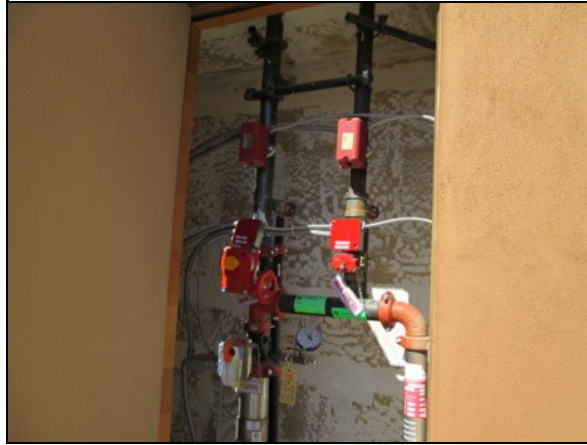
Comp #: 785 Sprinkler System - Repair

History: Repaired in 2023 for ~\$11,000.

Comments: The 2023 project included replacing numerous valves, pipes, and signs. There is no record of any widespread repairs in the past. This component funds similar projects going forward.

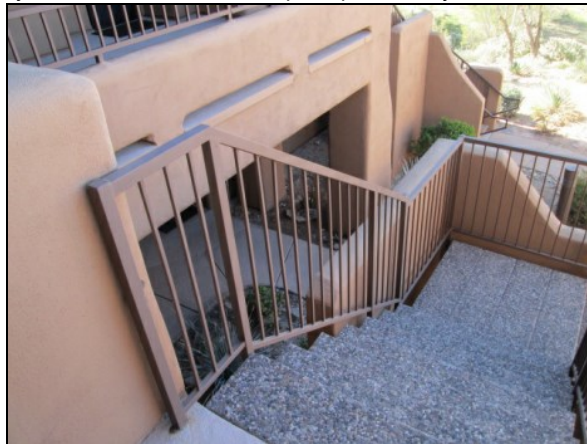
Comments: Surfaces are generally faded and weathered. Repaint periodically to maintain the appearance and to inhibit rust.

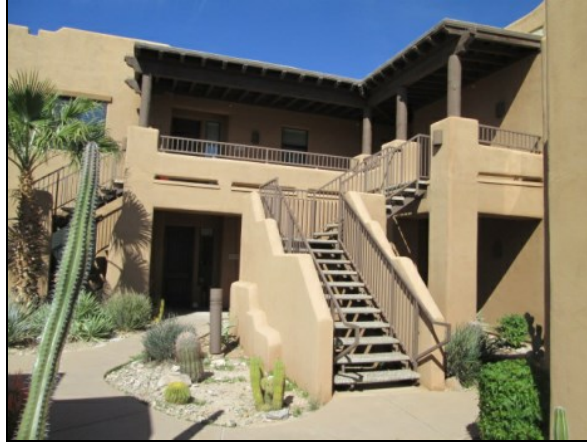
Comments: 2017 Cost included the building exteriors (stucco, metal, wood, decks), vehicle gates, fencing, bollard lights, etc. This component funds to repaint the building exterior stucco and wood surfaces. Surfaces are faded, cracking and in poor condition. Periodic repainting should be expected to maintain the appearance and to keep the surfaces properly sealed. Although the paint has a 10-year warranty, the useful life was reduced based on the recommendation of Titan Painting.

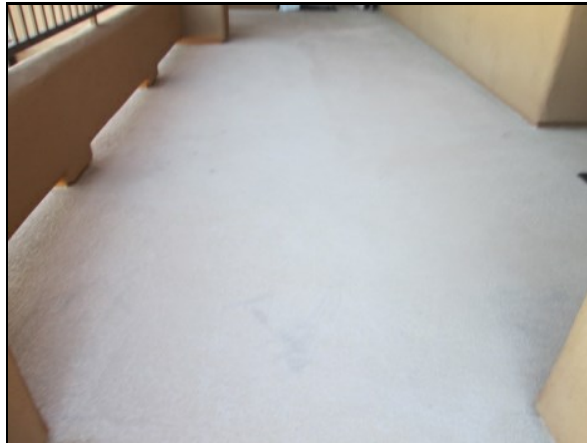
Comments: Landing decks have a coating applied, similar to a pool deck. Expect to recoat, or resurface, the decks at some point in the future. No peeling or chipping noted. The combined cost with the seal/repair component accounts for total cost estimate.

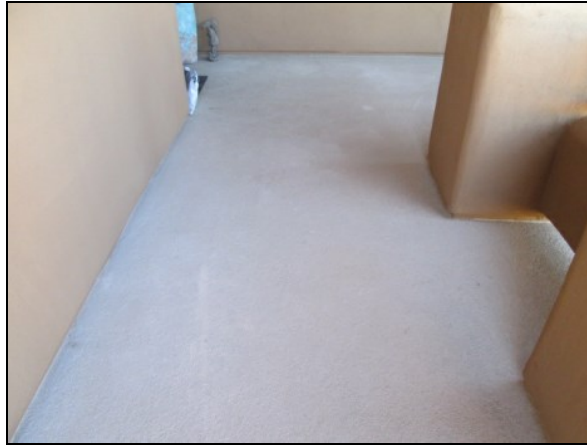
Comp #: 1155 Landing Decks - Seal/Repair

Comments: This component funds to periodically patch cracks and seal/paint the landing decks to cover stains and restore the appearance. No issues observed. Based on age, sealing should be needed in the near future to make sure surfaces are properly sealed.

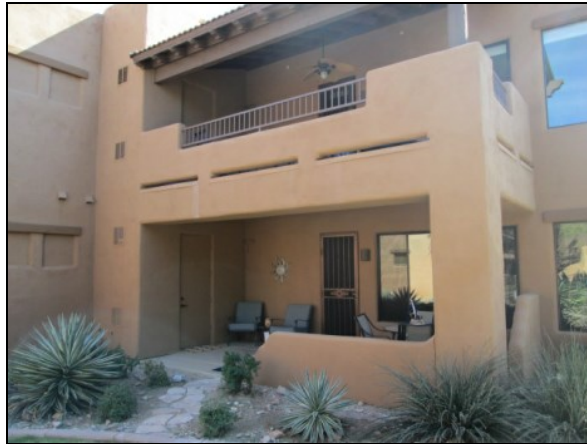
Funded?: No. Each owner is responsible to maintain and repair their balcony deck, not the association.

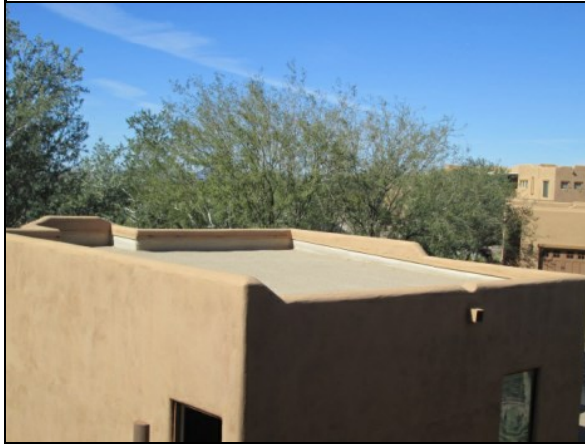
Comp #: 1300 Foam Roofs - Replace

Comments: Long life expectancy if recoated periodically as recommended. No problems observed or reported. Combined cost with the recoat component accounts for total cost estimate.

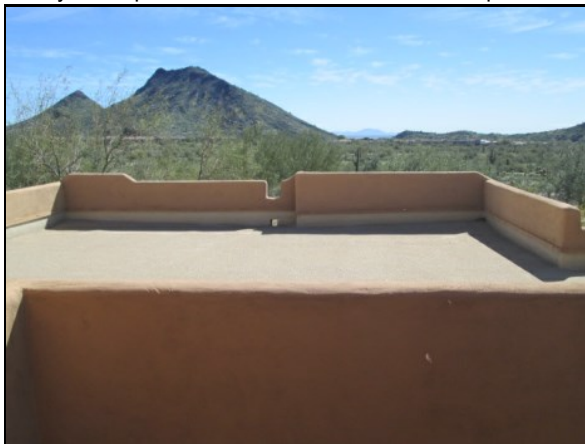
Comments: Periodic recoating of the roofs should be expected to prolong actual replacement. Failure to recoat the roofs will lead to premature replacement. Periodic cleanings and parapet repairs should be handled as an Operating expense. It was reported that the coating has a 10 year warranty. Life span was extended at the client's request.

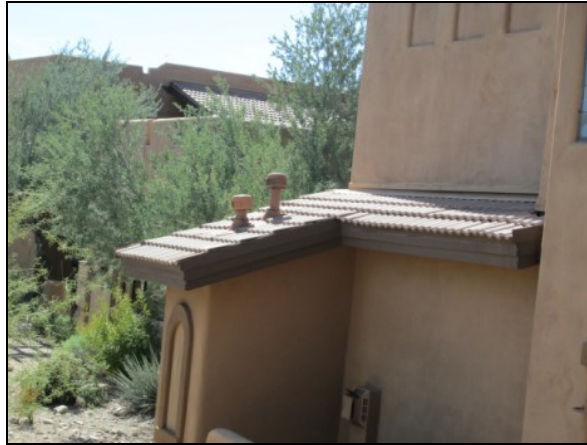
Comments: These are concrete tile roof systems. Underlayment is the true waterproofing component of these roofs. Although it is not visible to inspect, replacement will be needed eventually. Life span will vary depending on the quality of underlayment installed as well as regular roof maintenance. No problems observed or reported.

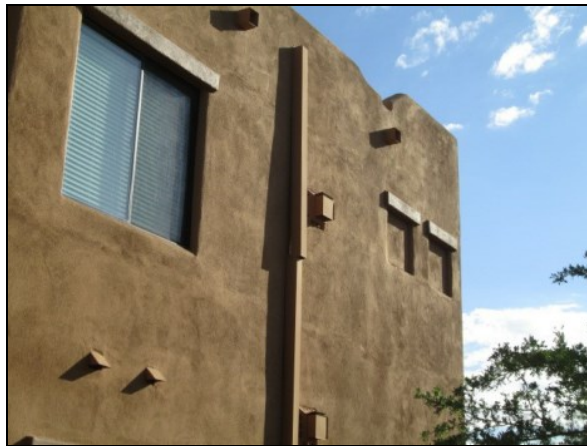
Comp #: 1310 Gutters/Downspouts - Repair

Funded?: No. Gutters and downspouts should be inspected periodically and repaired when needed as an Operating expense.
