## The Shores Villas HOA *Scottsdale, AZ*

Report #: 36311-0  
Beginning: January 1, 2024  
Expires: December 31, 2024

# RESERVE STUDY "Full"

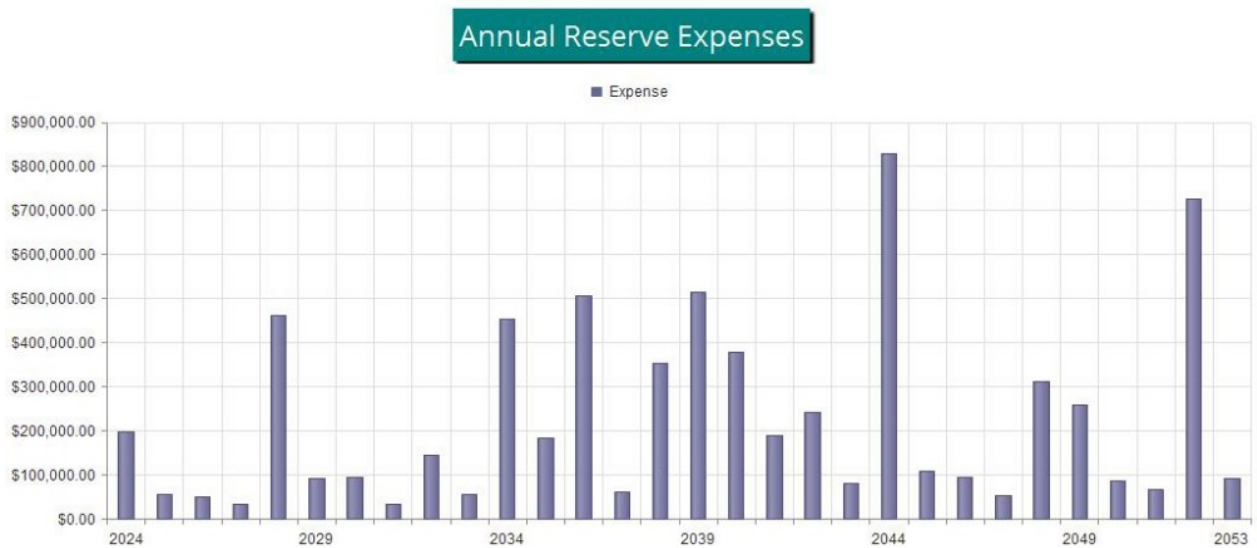
Figure 1

The chart below summarizes the projected future expenses at your association as defined by the Reserve Component List. A summary of these components is shown in the Component Details Table, while a summary of the expenses themselves is shown in the 30-yr Expense Summary Table.

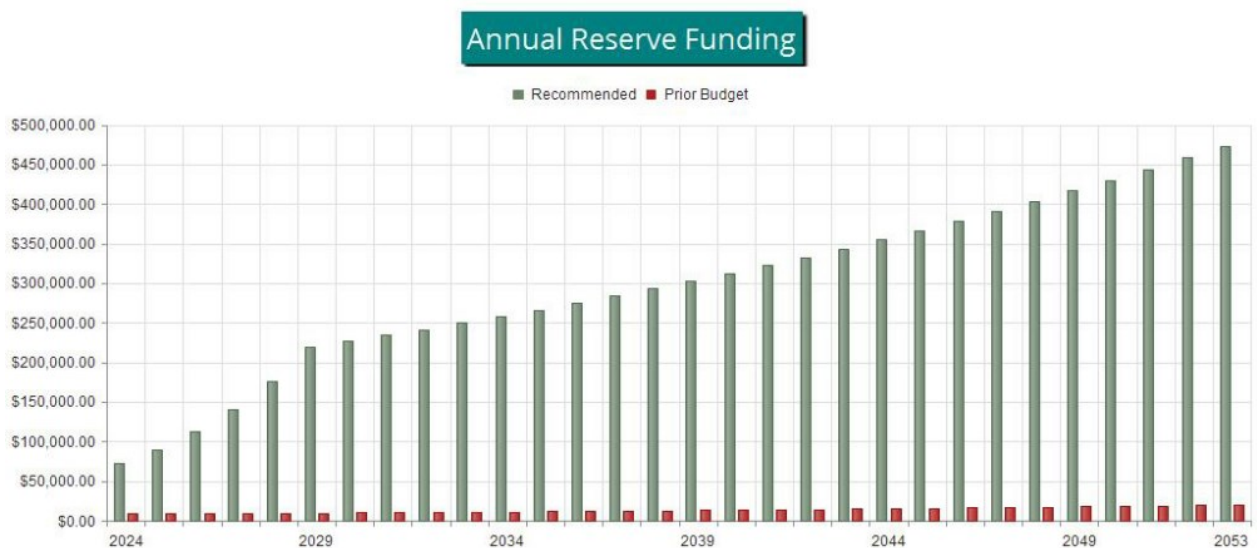
Figure 2

Budgeted Reserve contributions in 2023 significantly underfund the Reserve obligation. In comparison, components scheduled in this report are deteriorating at a rate of almost \$12,000/month, so significant contribution increases are needed over the next several years to properly fund Reserves and prevent the need for special assessments. Based on your current Percent Funded and cash flow requirements, we recommend budgeting Monthly Reserve contributions of \$6,000 this Fiscal Year. Large annual increases are scheduled in the short-term, followed by more nominal annual increases thereafter to help offset inflation. The overall 30-year plan, in perspective, is shown below. This same information is shown numerically in both the 30-yr Summary and the Cash Flow Detail tables.

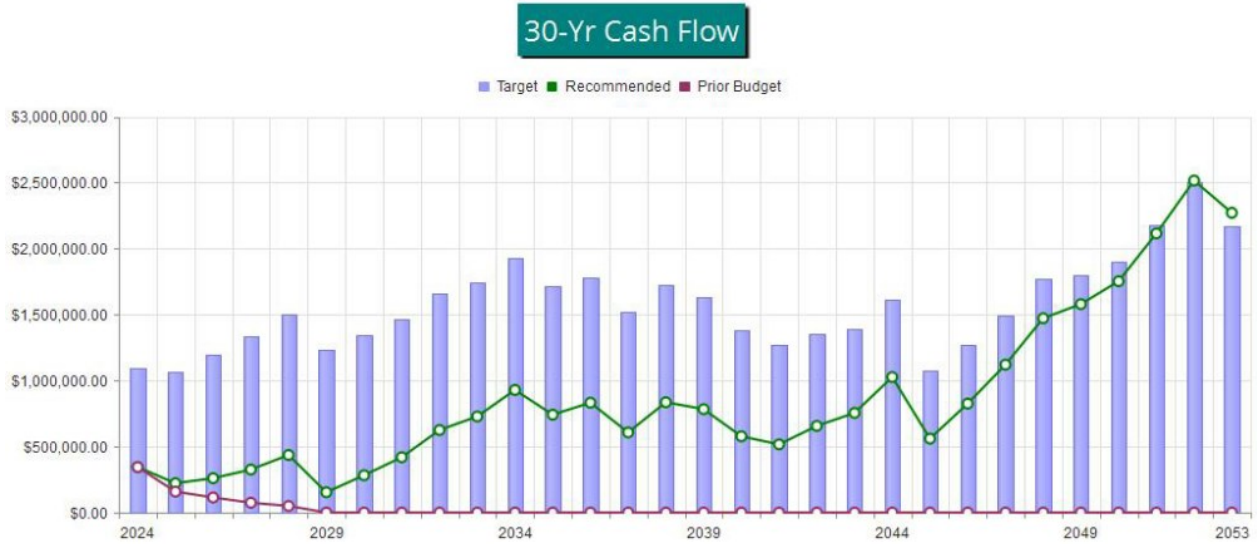
Figure 3

The following chart shows your Reserve balance under our recommended Funding Plan and your currently budgeted contribution rate, compared to the always-changing Fully Funded Balance target.

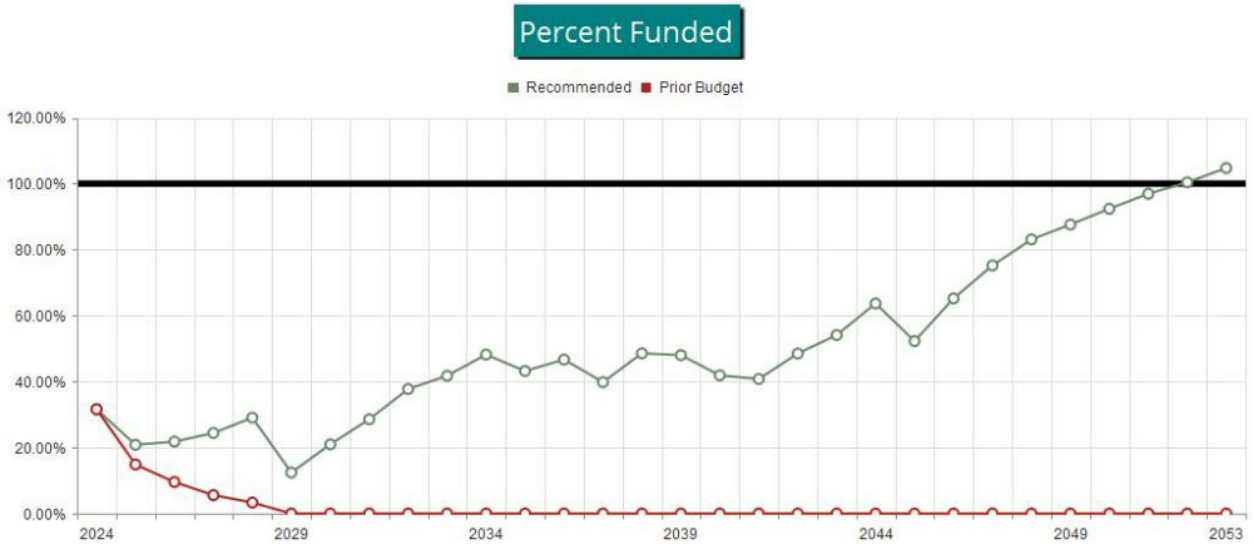
Figure 4

This chart shows the same information plotted on a Percent Funded scale. It is clear here to see how your Reserve Fund strength approaches the 100% Funded level under our recommended multi-year Funding Plan.

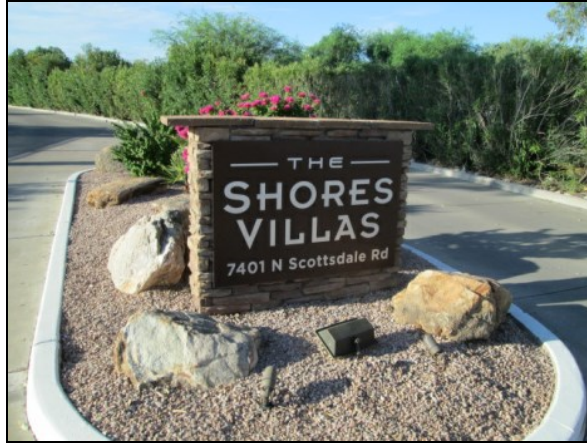
History: Replaced in 2018. Previous age is unknown.

Useful Life:  
20 years

Remaining Life:  
14 years

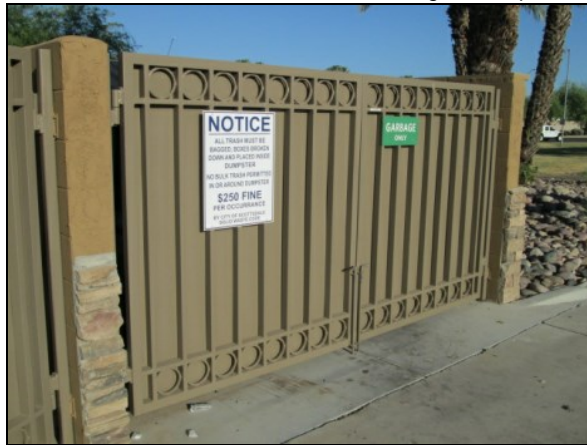
### Comp #: 120 Trash Gates - Replace

Useful Life:  
24 years

Remaining Life:  
19 years

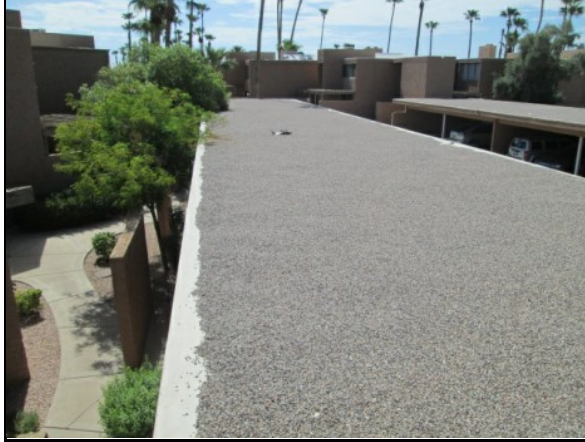
Useful Life:  
30 years

Remaining Life:  
10 years

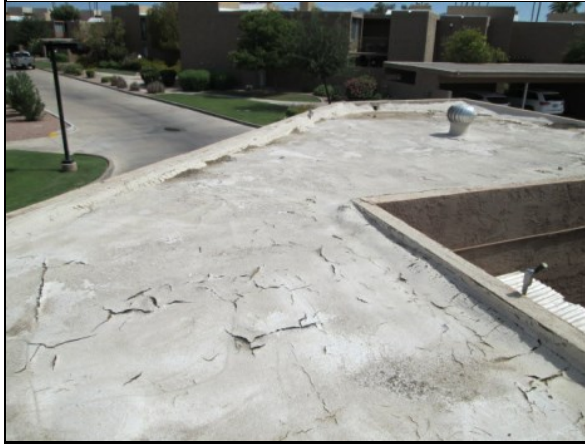
**Comp #: 1170 Foam Roof - Replace**

Comments: Storage building has a foam roof system. It is in terrible condition with extreme cracking, lifting, etc. There is no doubt this roof is leaking and potentially causing structure problems and mold issues. If the HOA intends to keep this structure, replacement of the roof should be a top priority. Life span is based on re-coating the roofs as recommended. Combined cost with the re-coat component accounts for the total estimated replacement budget.

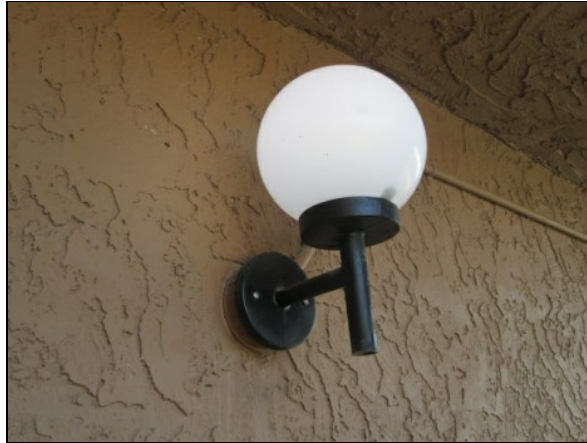
**Comp #: 1500 Light Fixtures - Replace**

Comments: Exterior light fixtures are not identified on the Maintenance Matrix, but fixtures mounted at front doors and stairways are reportedly HOA responsibility. They vary in age and style, so some owners have replaced their lights but other lights look old and dated. Complete replacement should be planned to update the lighting and restore uniformity.

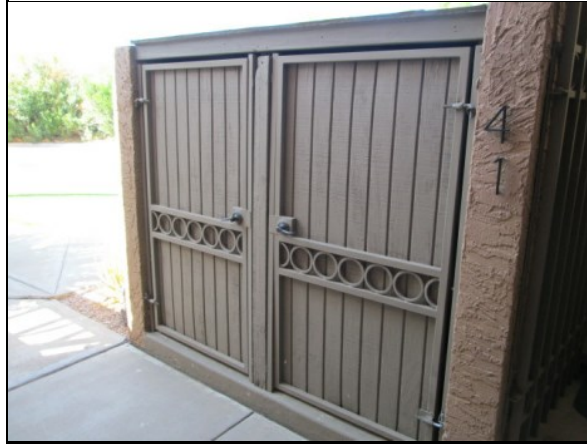
**Comp #: 1510 Storage Gates - Replace**

Comments: The A & C units each have a storage area with metal gate. Gates are like a security screen door with wood siding to block seeing inside. Age is unknown, but they appear to be in good shape, and no problems were reported. HOA is reportedly responsible for these gates, so long-term replacement should be planned. Painting is included as part of the Building Exteriors component.

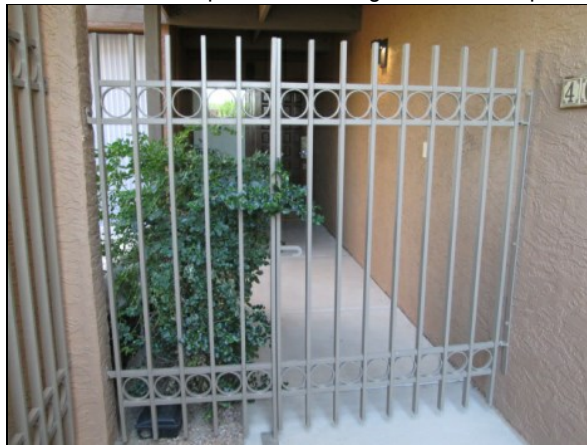
**Comp #: 1514 Entry Gates - Replace**

Comments: Each unit has a metal gate at its entry, and most also have a with a metal side panel/fence piece to complete the enclosure. Age is unknown, but they appear to be in good shape, and no problems were reported. HOA is reportedly responsible for these gates, so long-term replacement should be planned. Painting is included as part of the Building Exteriors component.

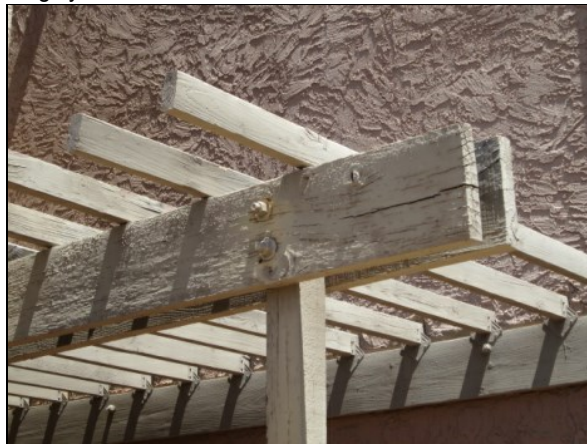
**Comp #: 1520 Wood Trellises - Replace**

Comments: A lot of the wood trellis structures are old and look deteriorated. Some have newer pieces of wood. There is no history of replacements or rebuilding. HOA received a proposal to replace the (2) trellis structures at a B-style unit in mid-2023 for \$5,585. There is no expectancy to replace all or most trellises at the same time. This component funds to replace (8) structures every 4 years in conjunction with the painting cycle.

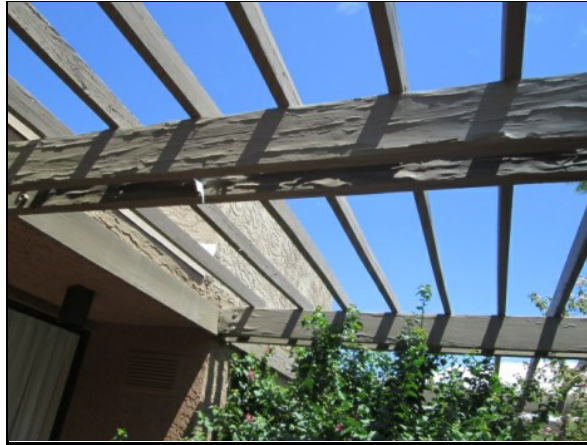
Comments: Quantity reflects the estimated surface area of beams for all wood trellis structures. Overall poor condition. In addition to a lot of deteriorated wood, paint surfaces are either peeling off or gone. This wood has high weather exposure and needs to be repainted regularly.

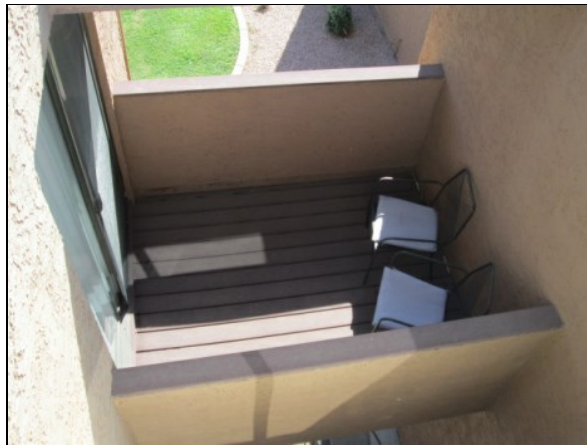
**Comp #: 1530 Balcony Decks - Replace/Resurface**

Funded?: No. Per the Maintenance Matrix, owners are responsible for their balcony floor surfaces. Undersides of the decks are encapsulated, so they are not just wood decks. There is no expectancy to replace or rebuild these decks in the foreseeable future. They should be inspected periodically by a qualified contractor or engineer to ensure structural integrity and resident safety. Inspections and repairs should be addressed as a maintenance expense when needed.

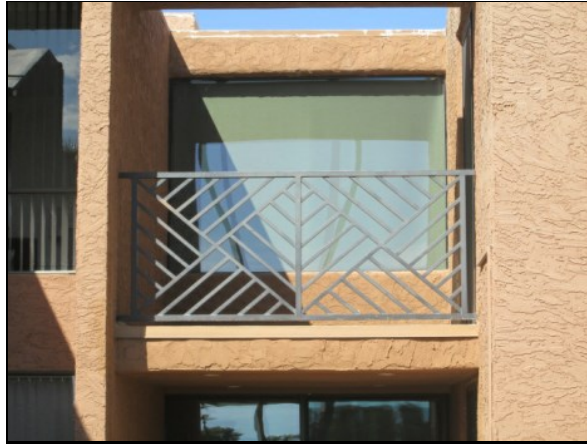
**Comp #: 1534 Balcony Rails - Replace**

Funded?: No. Balcony rails have an extended life span with no expectancy to replace in the foreseeable future. They should be inspected periodically by a qualified contractor or engineer to ensure structural integrity and resident safety. Inspections and repairs should be addressed as a maintenance expense when needed. Painting is included as part of the Building Exteriors component.

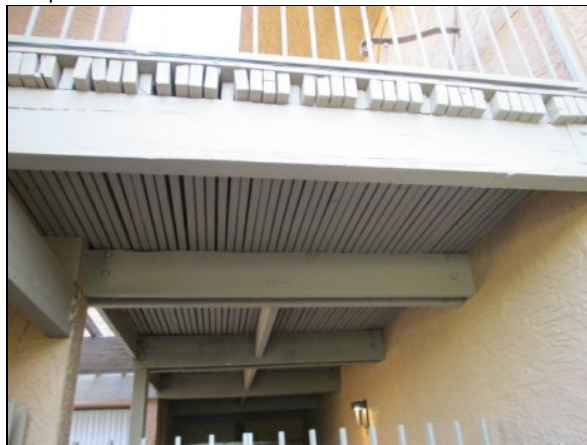
**Comp #: 1540 Landing Decks - Replace**

Comments: There is a wood stairway and upper landing deck to access the 2nd floor C-units. Upper landings are mostly covered by the roof, but not completely. No problems were observed or reported. HOA is reportedly responsible for these structures. They should be inspected periodically by a qualified contractor or engineer to ensure structural integrity and resident safety. Long life span anticipated. Due to the wood construction along with some weather exposure, replacement or rebuilding the upper landing decks and stairways should be anticipated.

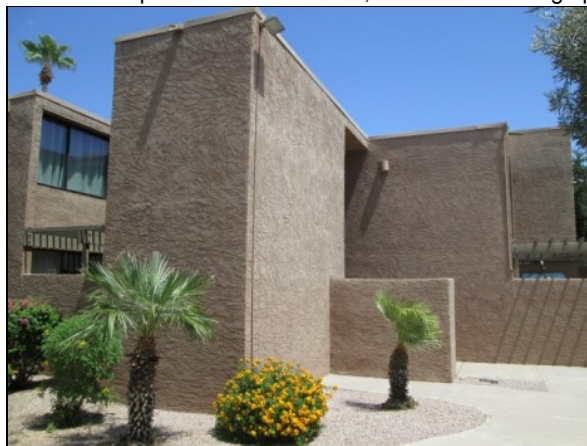
Comments: This component funds to paint ~222,000 sq ft of stucco surfaces, 644 LF of metal patio gates & balcony rails, (6) metal trellises, ~3,000 sq ft of non-exposed wood surfaces (underside of 2nd floor landings & stairways), and (51) unit front doors. Conditions vary but in fair shape overall. Sections look aged and discolored. Some patched spots were touched up with paint that does not matching. Community could use a repaint in the near future, but this is not a high priority yet.

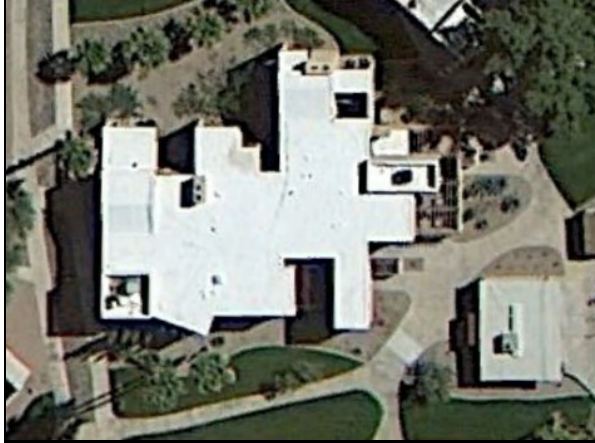
**Comp #: 1500 Foam Roofs (A) - Replace**

History: Replaced around 2012.

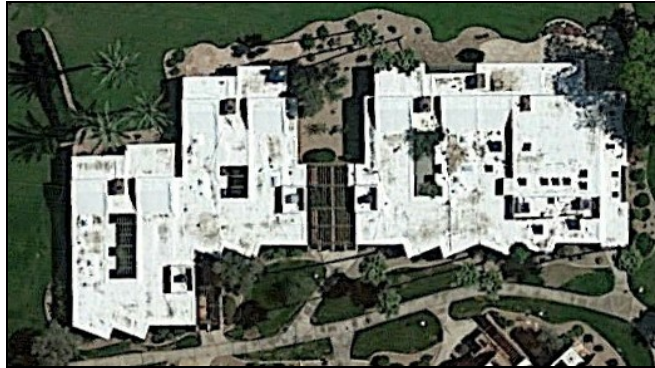
**Comp #: 1504 Foam Roofs (B) - Replace**

History: Replaced in 2017. Previous age is unknown.
